**Region 9 Enforcement Division
75 Hawthorne Street
San Francisco, CA 94105**

Inspection Date(s):	9/30/2015		
Time:	Entry: 10:45	Exit: 11:30	
Media:	Water		
Regulatory Program(s)	Clean Water Act NPDES /CAFO Dairy		
Company Name:	SD Farms II		
Facility or Site Name:			
Facility/Site Physical Location:	Ex. 6 Personal Privacy (PP)		
Geographic Coordinates:			
Mailing address:	c/o Heritage Farm Office		
	Ex. 6 Personal Privacy (PP)		
Facility/Site Contact:	Amos DeGroot	Title: Operator	
	Phone: Ex. 6 Personal Privacy (PP)	Email:	
Facility/Site Identifier:	NPDES CAG018001 / Order R8-2013-0001, General waste discharge requirements for CAFOs (dairies and related facilities)		
NAICS:	112120 Dairy Cattle and Milk Production		
SIC:	0241 Dairy Farms		
Facility/Site Personnel Participating in Inspection:			
Name	Affiliation	Title	Email
Nancy Goedhard	SD Farms II	Business Manager	
Simone Leal-Iepe	SD Farms II	Facility Manager	
EPA Inspector(s):			
John Tinger	EPA	Engineer	Tinger.John@EPA.gov
Federal/State/Tribal/Local Representatives:

SECTION I – INTRODUCTION

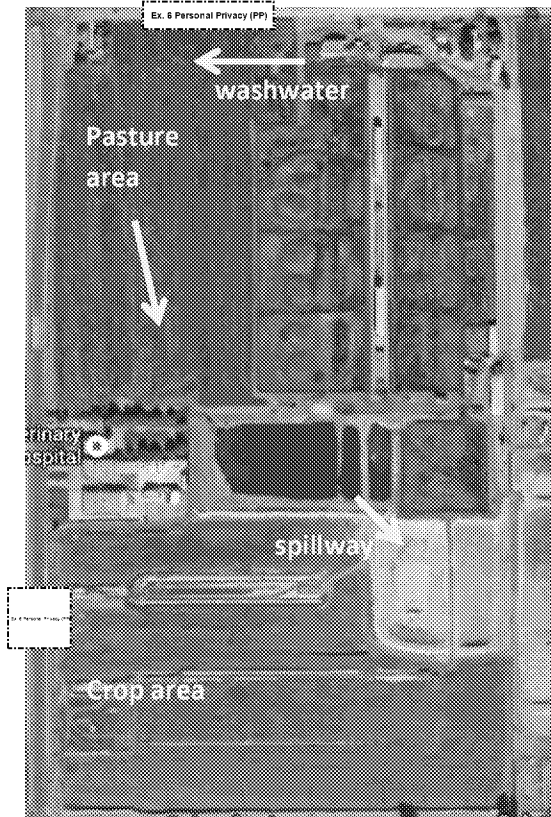
Photo 1: Overview – (google image)

Stormwater from the corrals generally drains towards the south (see photo 1), with most stormwater directed to the pond located in the middle of the facility (photo 4), which is the first in a series of ponds. In the event the middle ponds fill up, water will flow over a spillway (photo 5) to the central-southern pond (photo 6). Operators noted that in 2009 there was sufficient rainfall for the middle ponds to overflow into the central-southern pond (photo 7). In the event the central-southern pond fills, operators have the ability to pump water to the southeastern pond. The southeastern pond receives runoff only from the eastern edge of the facility and will generally have capacity in the event pumping is needed. Operators stated they have never needed to pump to the southeastern pond.

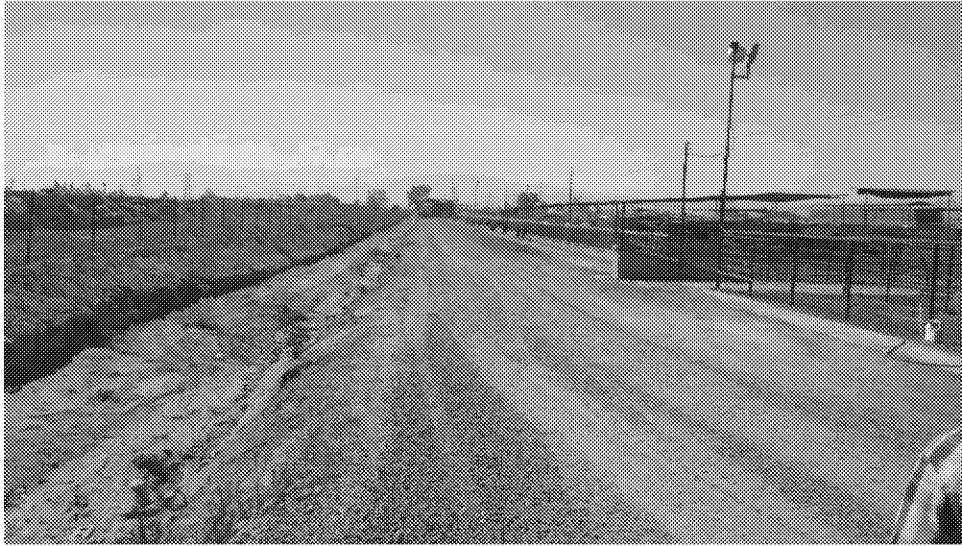
Photo 3: eastern boundary looking south. Drainage ditch conveys stormwater from street past property.

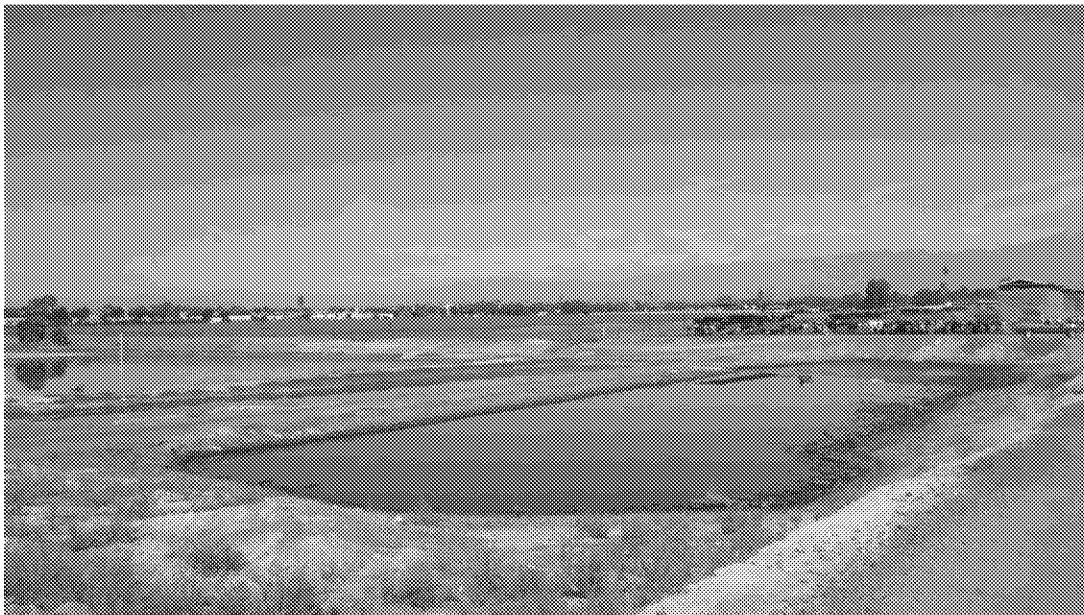
Photo 4: middle ponds

The 2 southern ponds were dry. The middle ponds each held several feet of wastewater. During the inspection, wastewater was observed flowing into the middle pond.
